The photograph shows the marble drain covers in the main square of Mugla University. The approximate dimensions of the marble sections are 4x4x30 cm.

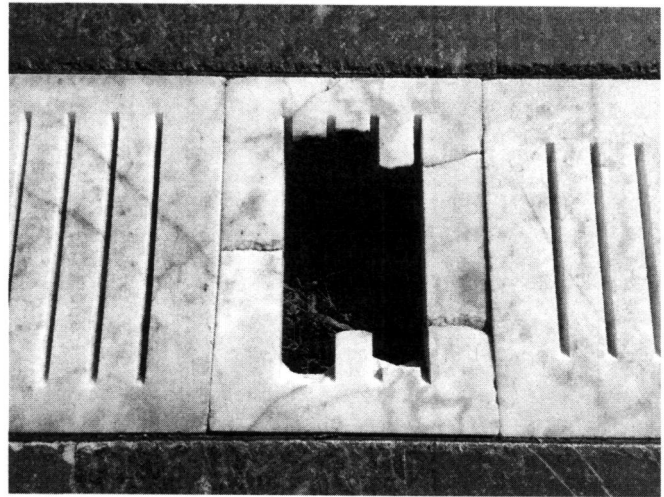
They broke due to poor design. The sections were too thin and too narrow to take the loading of a person's weight. Marble is brittle and can not take bending tension.

$$\sigma = 69 \text{ MPa} \leftarrow \text{too large for marble}$$

The drain covers must be redesigned to have a larger cross-section and larger moment of inertia, I .

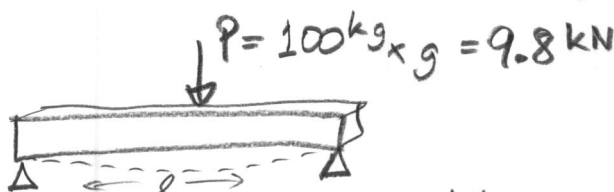
$$M_{\max} = \frac{Pl}{4} = \frac{9.8 \text{ kN} \times 0.3 \text{ m}}{4}$$

$$M_{\max} = 0.735 \text{ kN}\cdot\text{m}$$

$$I = \frac{4 \times 4^3}{12} = 21.3 \text{ cm}^4$$

$$\sigma = \frac{(0.735 \text{ kN}\cdot\text{m})(2 \text{ cm})}{(21.3 \text{ cm}^4)}$$
